Studebaker

Service Letter

SUBJECT WATER IN THE TAIL LAMP HOUSING
1964 STUDEBAKER MODELS - EXCEPT
STATION WAGONS

NUMBER F-1964-5

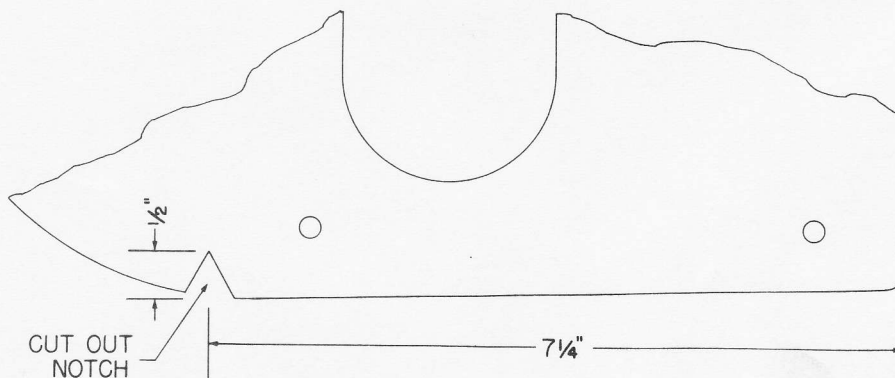
There is a possibility that water may enter the tail light housing on some 1964 model passenger cars (except station wagons) and result in an inoperative tail light. There are two probable causes for this condition.

1. Improper sealing of the lens to lamp housing.
2. Improper sealing of lamp housing to the rear fender.

1. Place the lamp assembly face downward in a container having approximately two inches of water in it and note any points of leakage. Should leakage into the lamp assembly be noted it will be necessary to install a new Tail Lamp Lens Gasket, Part Number 1356262.
2. Modify the tail lamp to body gasket as shown in the illustration and install the tail light assembly.
