Studebaker

Service Letter

SUBJECT MISALIGNMENT OF FRONT SEAT BACKS ON
MODELS EQUIPPED WITH RECLINING SEATS

NUMBER F-1966-3

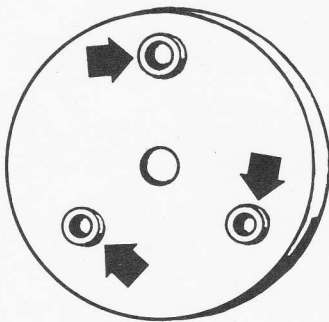
Fig. 1

You may occasionally encounter a condition where the front seat backs of cars equipped with reclining seats are not aligned in fore and aft position. Investigation of such a condition indicates the misalignment to be generally caused by improper mounting of the adjusting mechanism internal gear housing on the seat frame. The condition can be corrected by the following procedure:

1. Remove the reclining seat back control, as outlined on page 8, Body Section, Group V of the 1962-64 Passenger Car Shop Manual.
2. The mounting holes in seat frame for internal gear housing are drilled to close tolerances. Remove any burrs that might have occurred due to previous misalignment. Also check mounting lugs (See Fig. 1) on back of internal gear housing for distortion or burrs. Correct as required.
3. Place internal gear housing on seat frame. Make sure mounting lugs squarely enter seat frame holes and install retaining bolts.
4. Tighten retaining bolts progressively to maintain alignment. The two smaller bolts should be tightened to 3-4 ft. torque; the larger bolt to 8-9 lbs. ft. torque.
5. Reassemble control mechanism as outlined in the shop manual. Be sure to use the correct control lever spring and to install the spring (3) as shown in Figure 2.
